SUBJECT Ships at the Baltic Shipyard in Leningrad

Annex: Views of Slip A of Baltic Shipyard with Legend

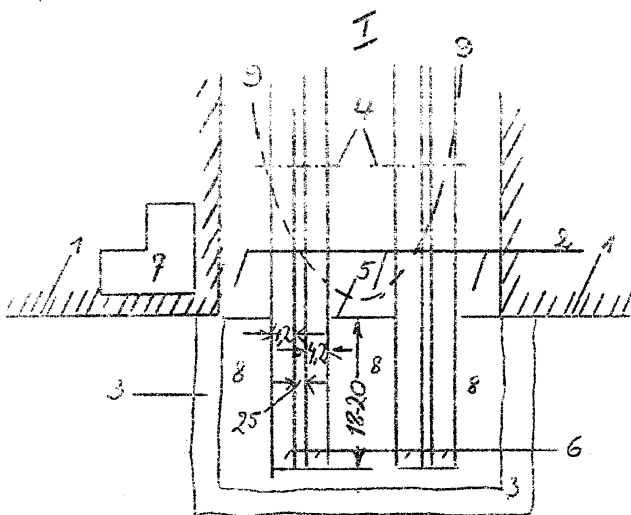
Top View of Lower End of Slip A

- Sketch I:
1. Quay wall.
 2. Concrete ship floor.
 3. Shut-off dam.
 4. Hinge in wooden floor?
 5. End of concreted floor of slip.
 6. Concrete support girders of launching-way.
 7. Pump station.
 8. Not concreted bottom in way of launch slip.
 9. Outline of the stern of the battleship hull on slip.

1. In late August 1946, the hull of a battleship was still lying on slip A in the Baltic Shipyard, Leningrad. A heavy bomb hit had penetrated to the slip through the middle section of the hull toward the starboard side. The damaged middle section, which constituted more than one-third of the total length of the hull, was broken up, and the slip underneath was repaired in the fall of 1946. The bow section was subsequently broken up; but, during the period from the spring to December 1949, one-third of it was rebuilt. No armor was seen. The rear section remained in position and the space for the middle section remained unoccupied as of December 1949. (1)

2. The lower part of the slip was completed and fitted with launching ways. Concrete work for these ways had been completed in December 1949 but the installation of the ways was only 50 percent completed. The length of the slip below the water level was 80 meters and below the level of the ground 120 meters. The deepest point of the floor of the slip lay 10 meters below the water level. A hinge was fitted in the wooden floor where the bottom touched the water level, thus allowing the wooden layer to float up when not in use. (2)

- (2) [] confirmed the completion of the launch slip, but saw no hinge. This hinge was probably the stopper by which the ship is released for the launching operation.

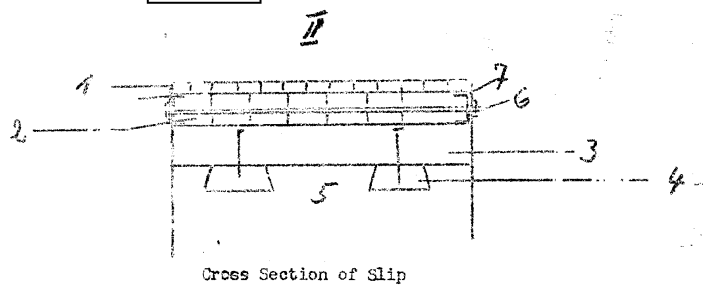
Cross Section of Slip

- Sketch II:
1. Oak-wood layer, carefully smoothed, 30 mm thick.
 2. Thick planks, laid in direction of launching.
 3. Thick planks, laid across the launching direction, 200 x 250 mm.
 4. Swallow-tail shaped wooden pieces in concrete, upon which plank layer 3 is nailed.
 5. Concrete bed.
 6. Two bolts going through plank layer 2.
 7. U-iron frames.

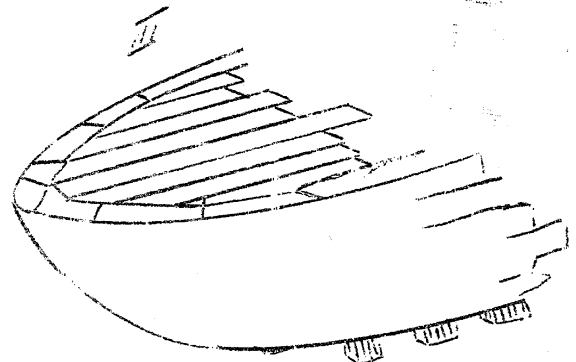
View of Stern

- (1) [] confirmed the heavy damage the bomb had caused, as well as the salvage work on the middle and forward sections of the ship. He believed, however, that the remaining part was moved lower and that, finally, when the stern was already removed, its open end was in line with the embankment(sic).
